**MINISTRY OF TRANSPORT OF THE REPUBLIC OF KAZAKHSTAN**  
**AVIATION ACCIDENT INVESTIGATION COMMISSION**

**PRELIMINARY REPORT**  
**BASED ON THE RESULTS OF THE INVESTIGATION OF THE AVIATION ACCIDENT**

| Aircraft type: | Embraer ERJ 190-100 IGW |
| State and registration<br>identification marks: | 4K-AZ 65 |

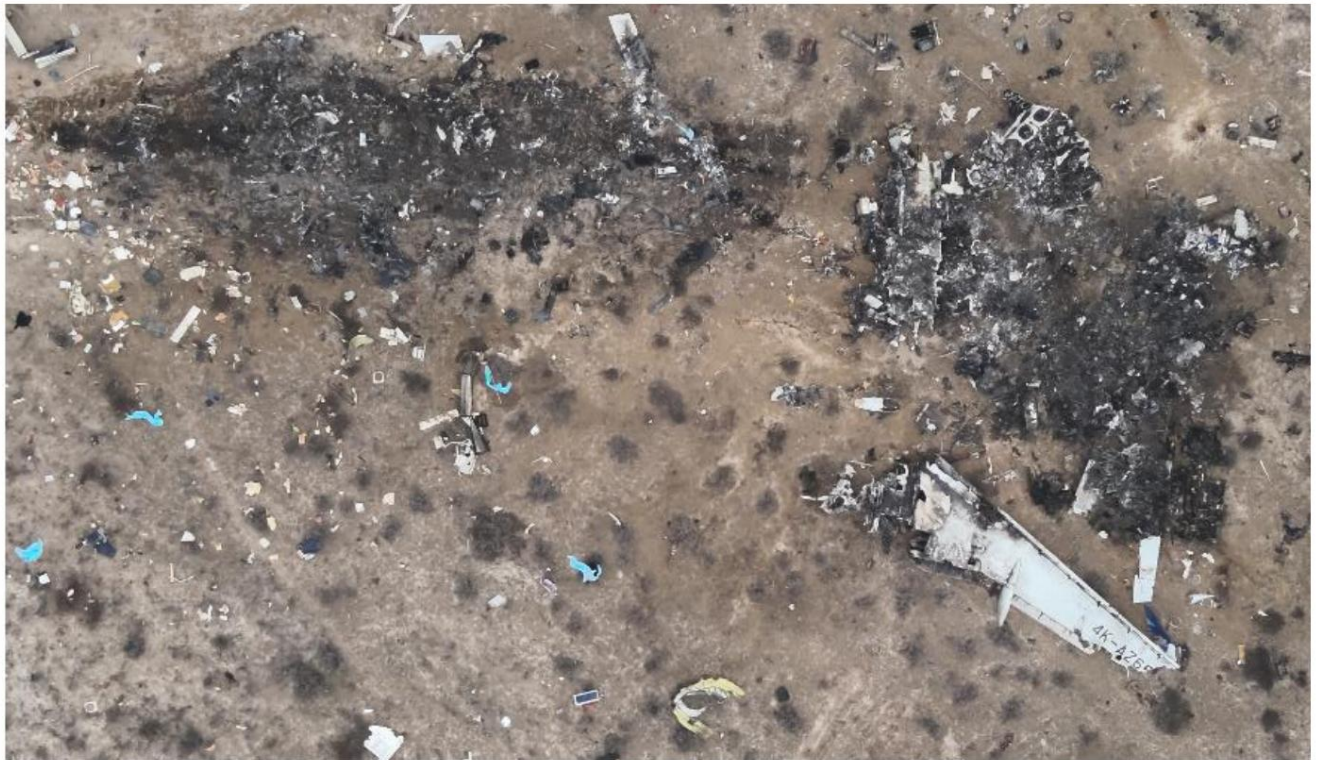
**Fig. 5. The main source of the fire  
(right wing, nose and center sections of the fuselage, center section and left wing)**

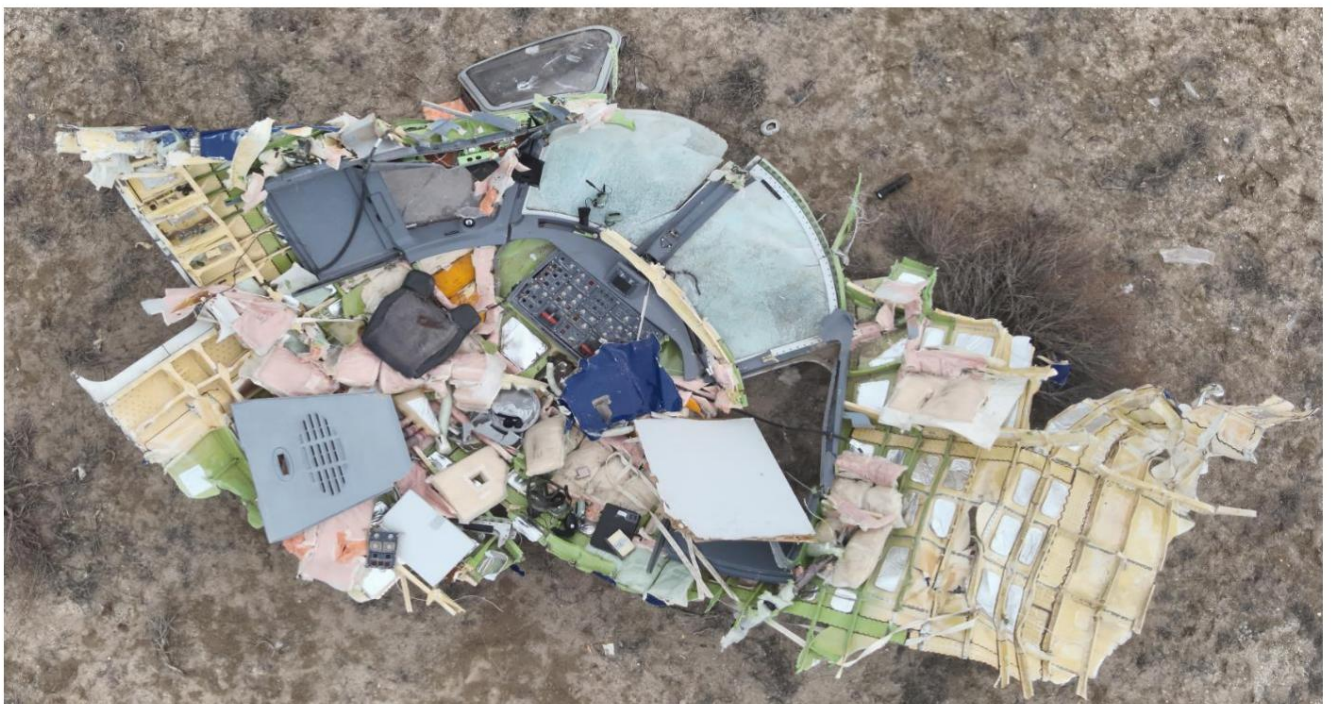
**Fig. 6. Cabin canopy and upper panel**

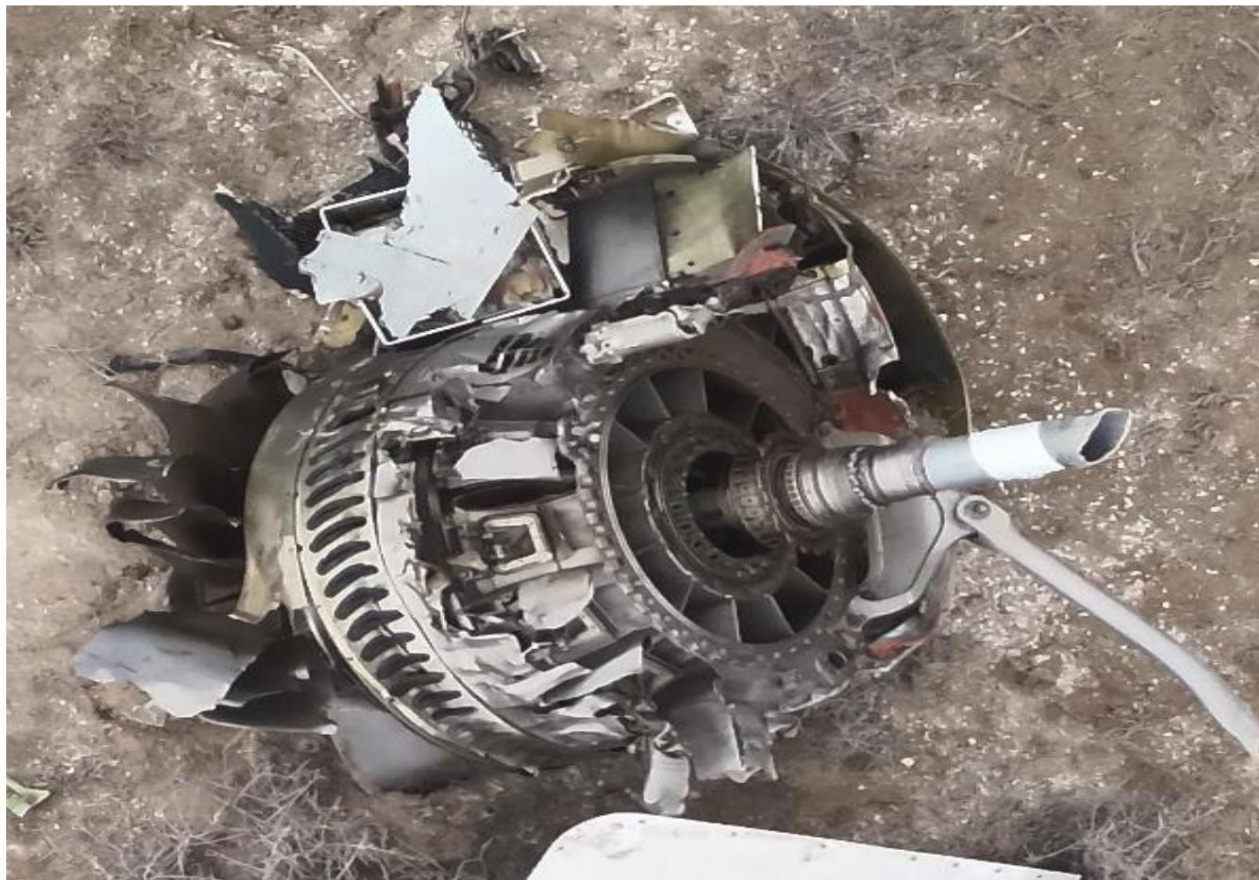
**Fig. 7. Front part of the right engine**

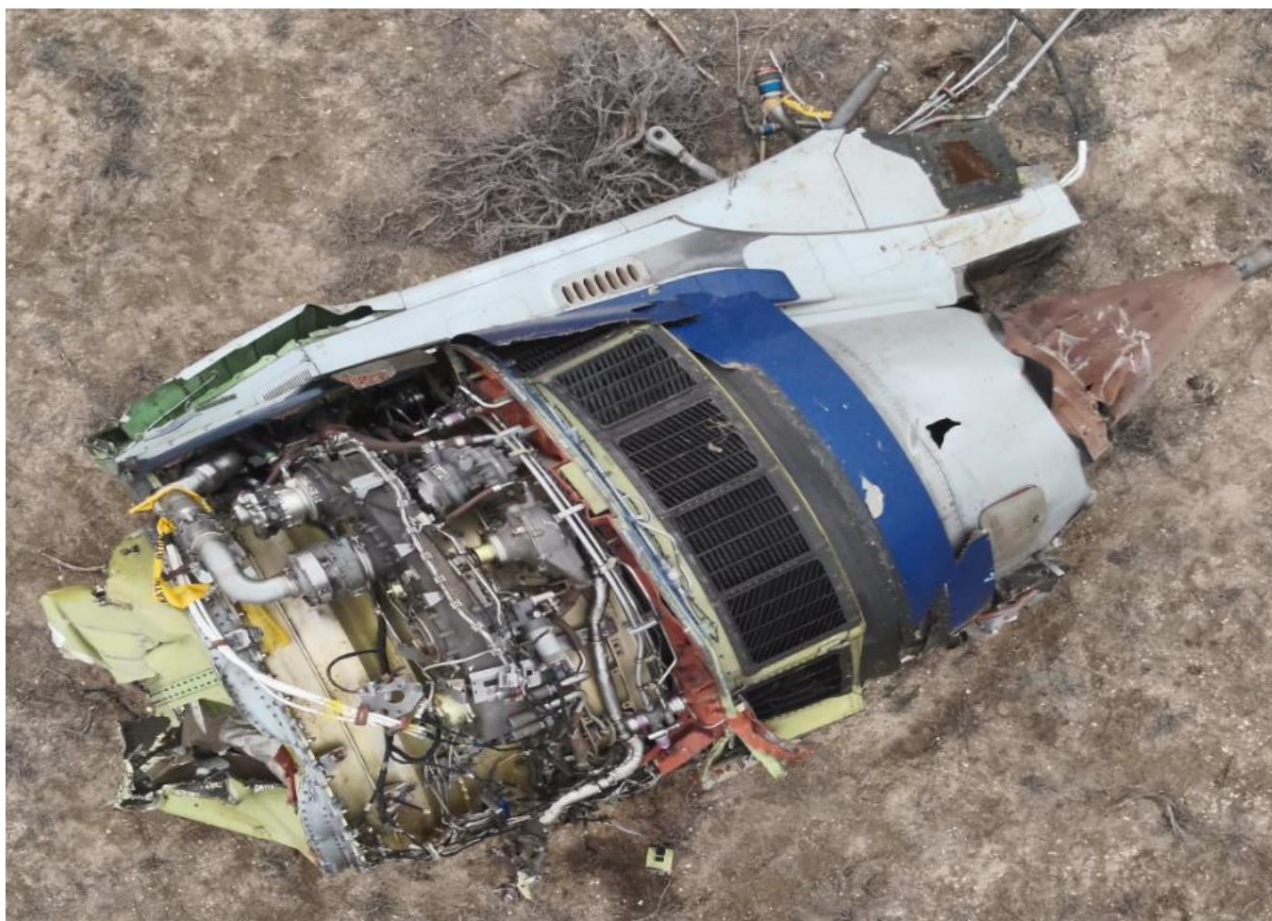
**Fig. 8. Left engine with part of the pylon**

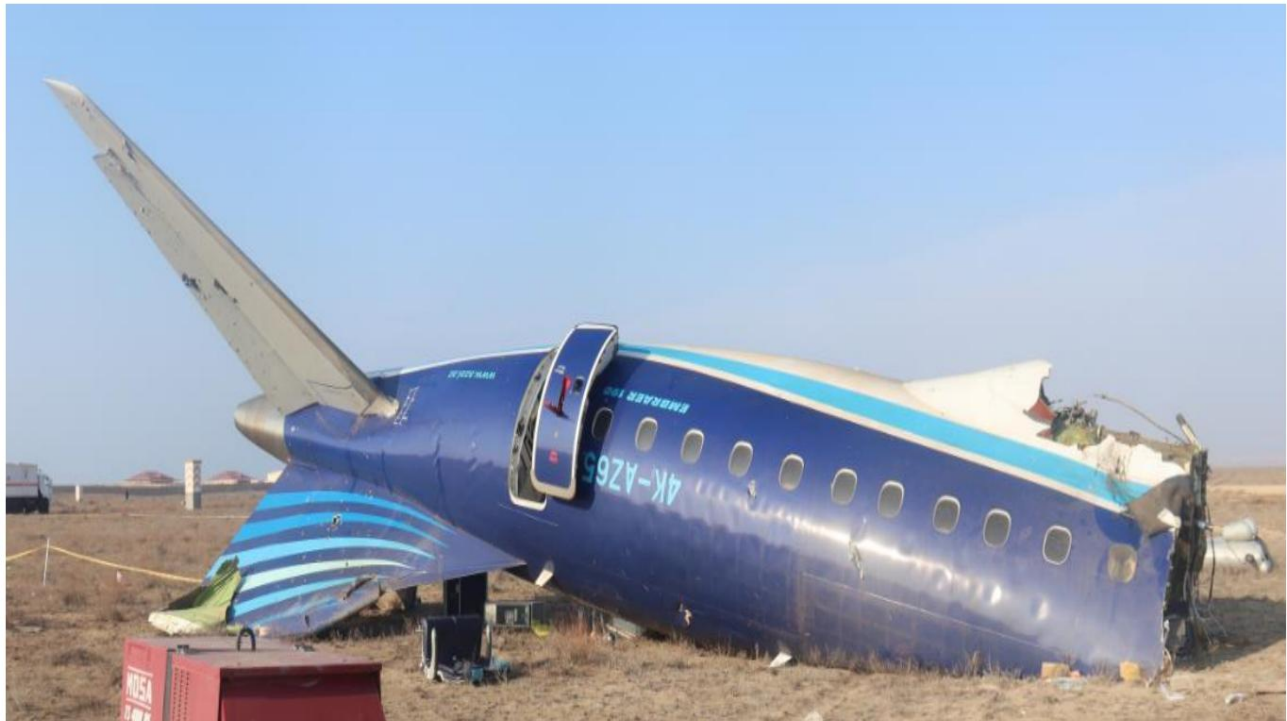
Fig. 9. Rear and tail part of the aircraft

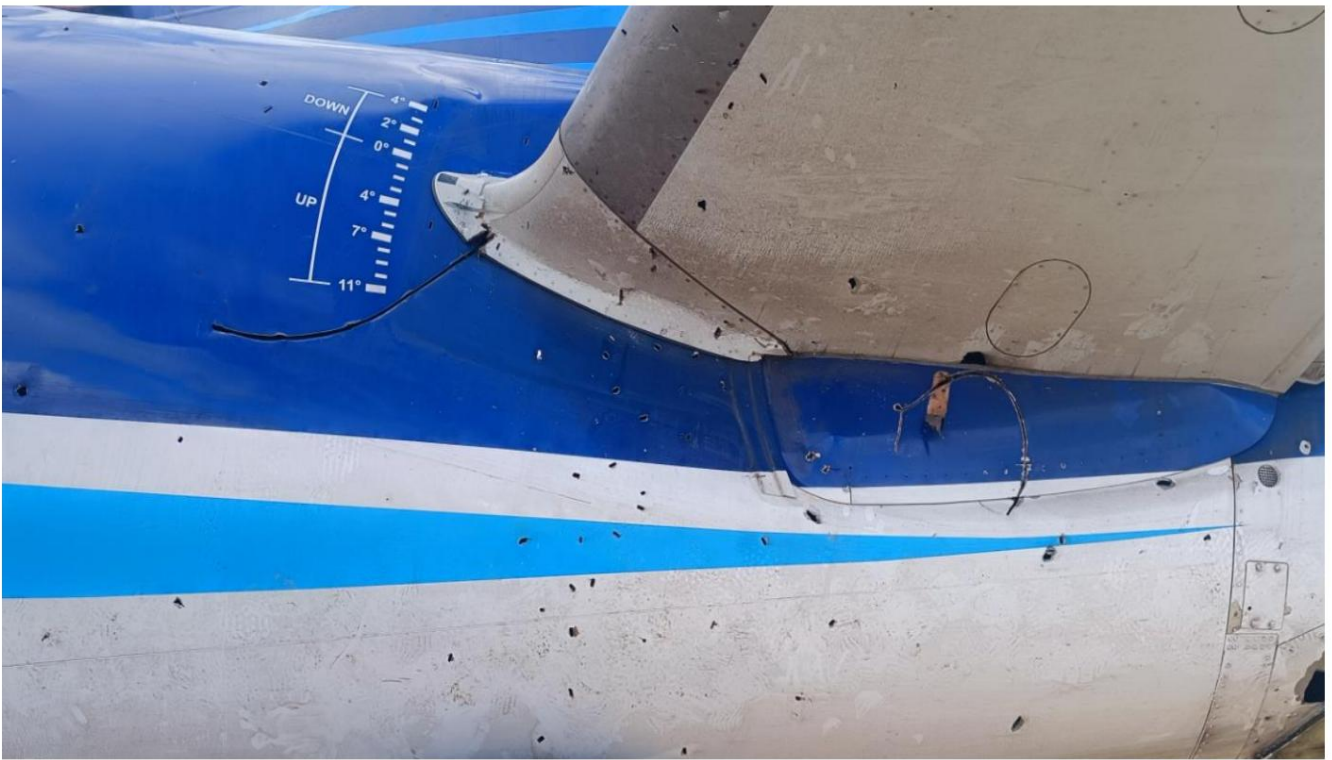
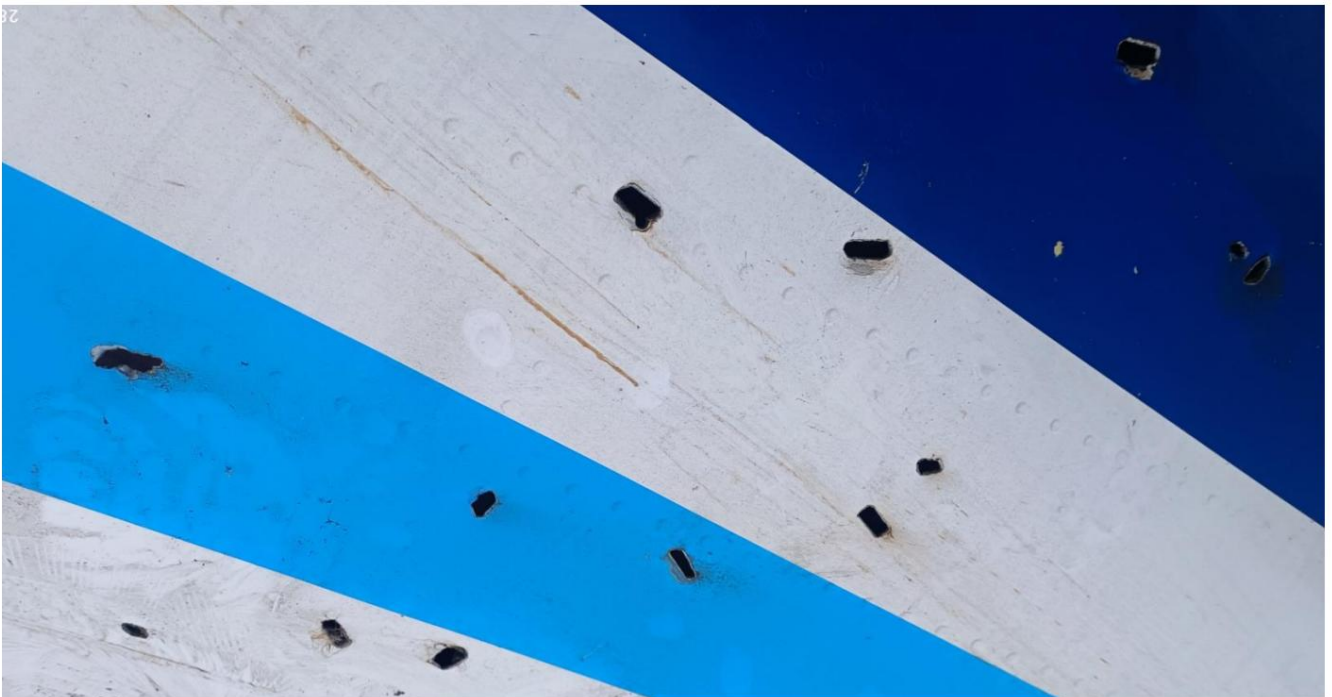
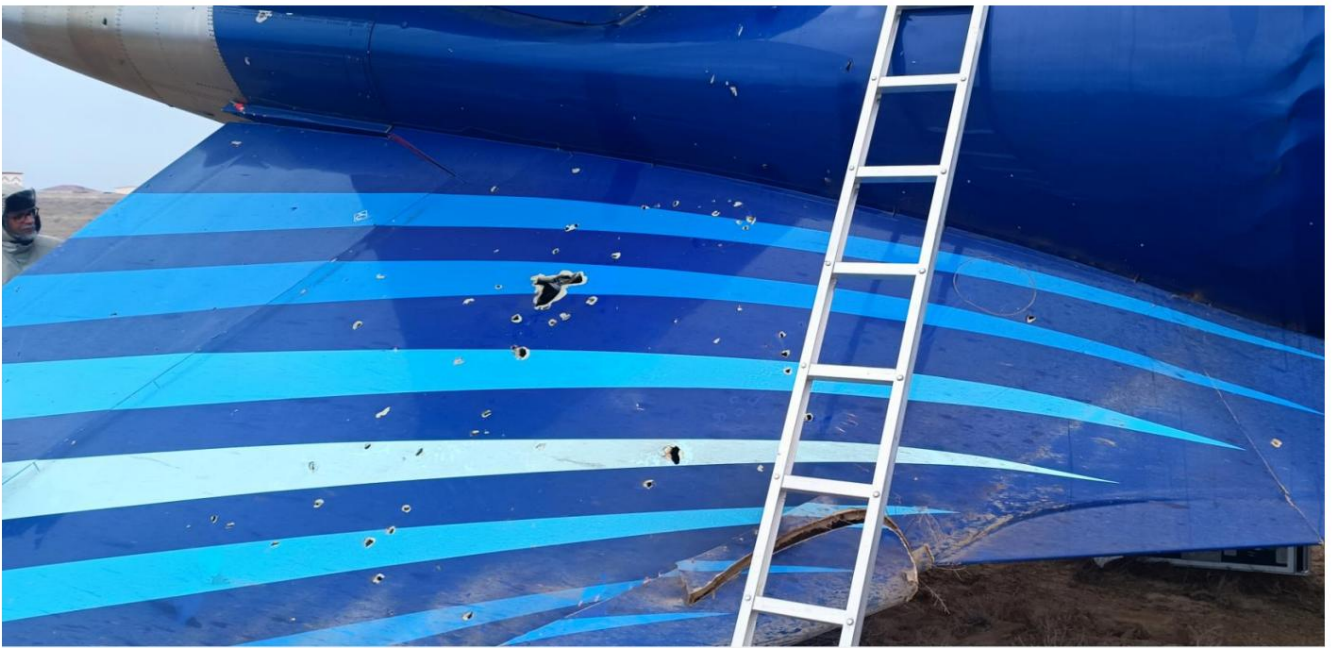
The commission of inquiry continues to conduct a detailed investigation. damage to the aircraft structures. Initial inspection of the surviving fragments revealed multiple through and non-through damages of various sizes and shapes in the tail section fuselage, vertical stabilizer and stabilizer, elevator and rudder. Similar damage was were found on the left engine and left wing of the aircraft, as well as on units and components of the aircraft. In some places, the damage has the correct rectangular shape.

**Fig. 10. Damage to the left side of the tail section**

**Fig. 11. Damage to the left side of the tail section**

**Fig. 12. Damage to the left side of the tail section**

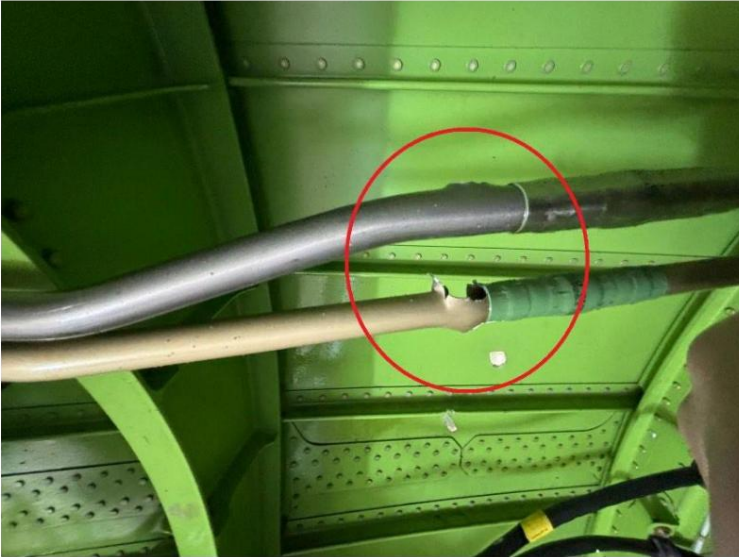
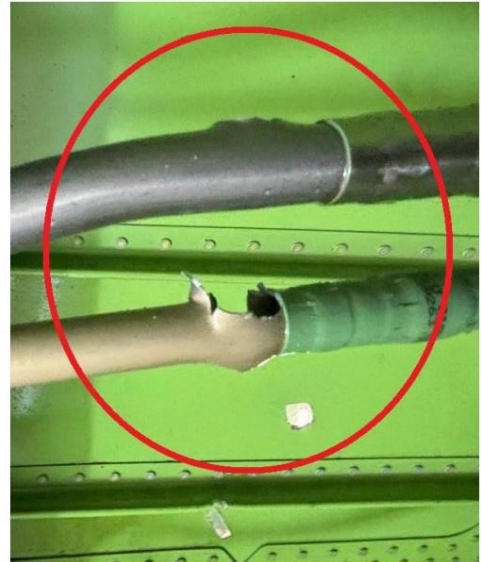
hydraulic systems 1, 2 and 3 before impact with the earth's surface, probably caused by external objects that have penetrated the components of the armed forces.

The consequence of this damage will be a loss of hydraulic fluid/pressure.

Fig. 13. Hydraulic system 1 – Damaged tube

Fig. 14. Hydraulic system 1 – Damaged tube - detailed view

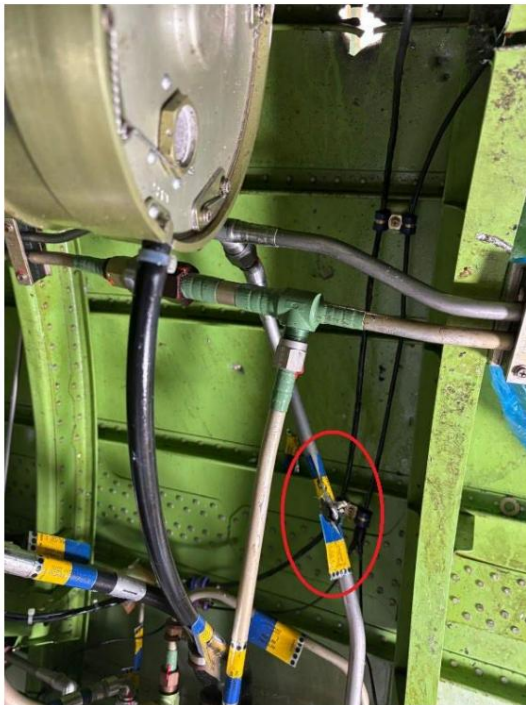
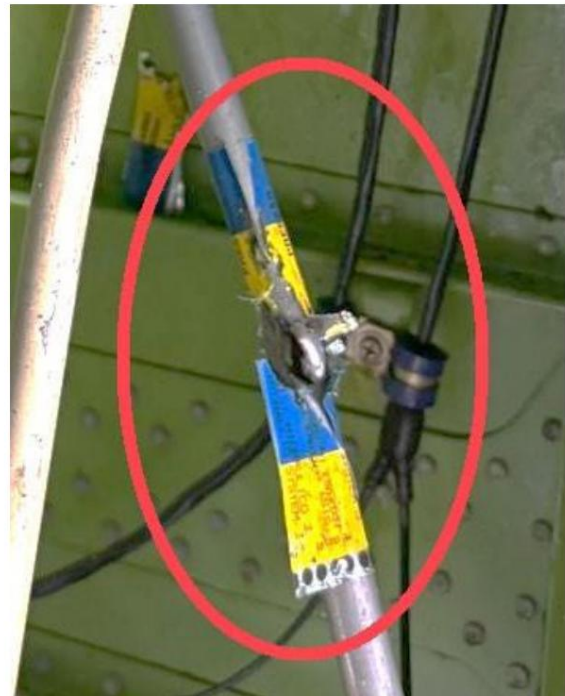
Fig. 15. Hydraulic system 3 – damaged tube

Fig. 16. Hydraulic system 3 – detailed view of the damaged tube

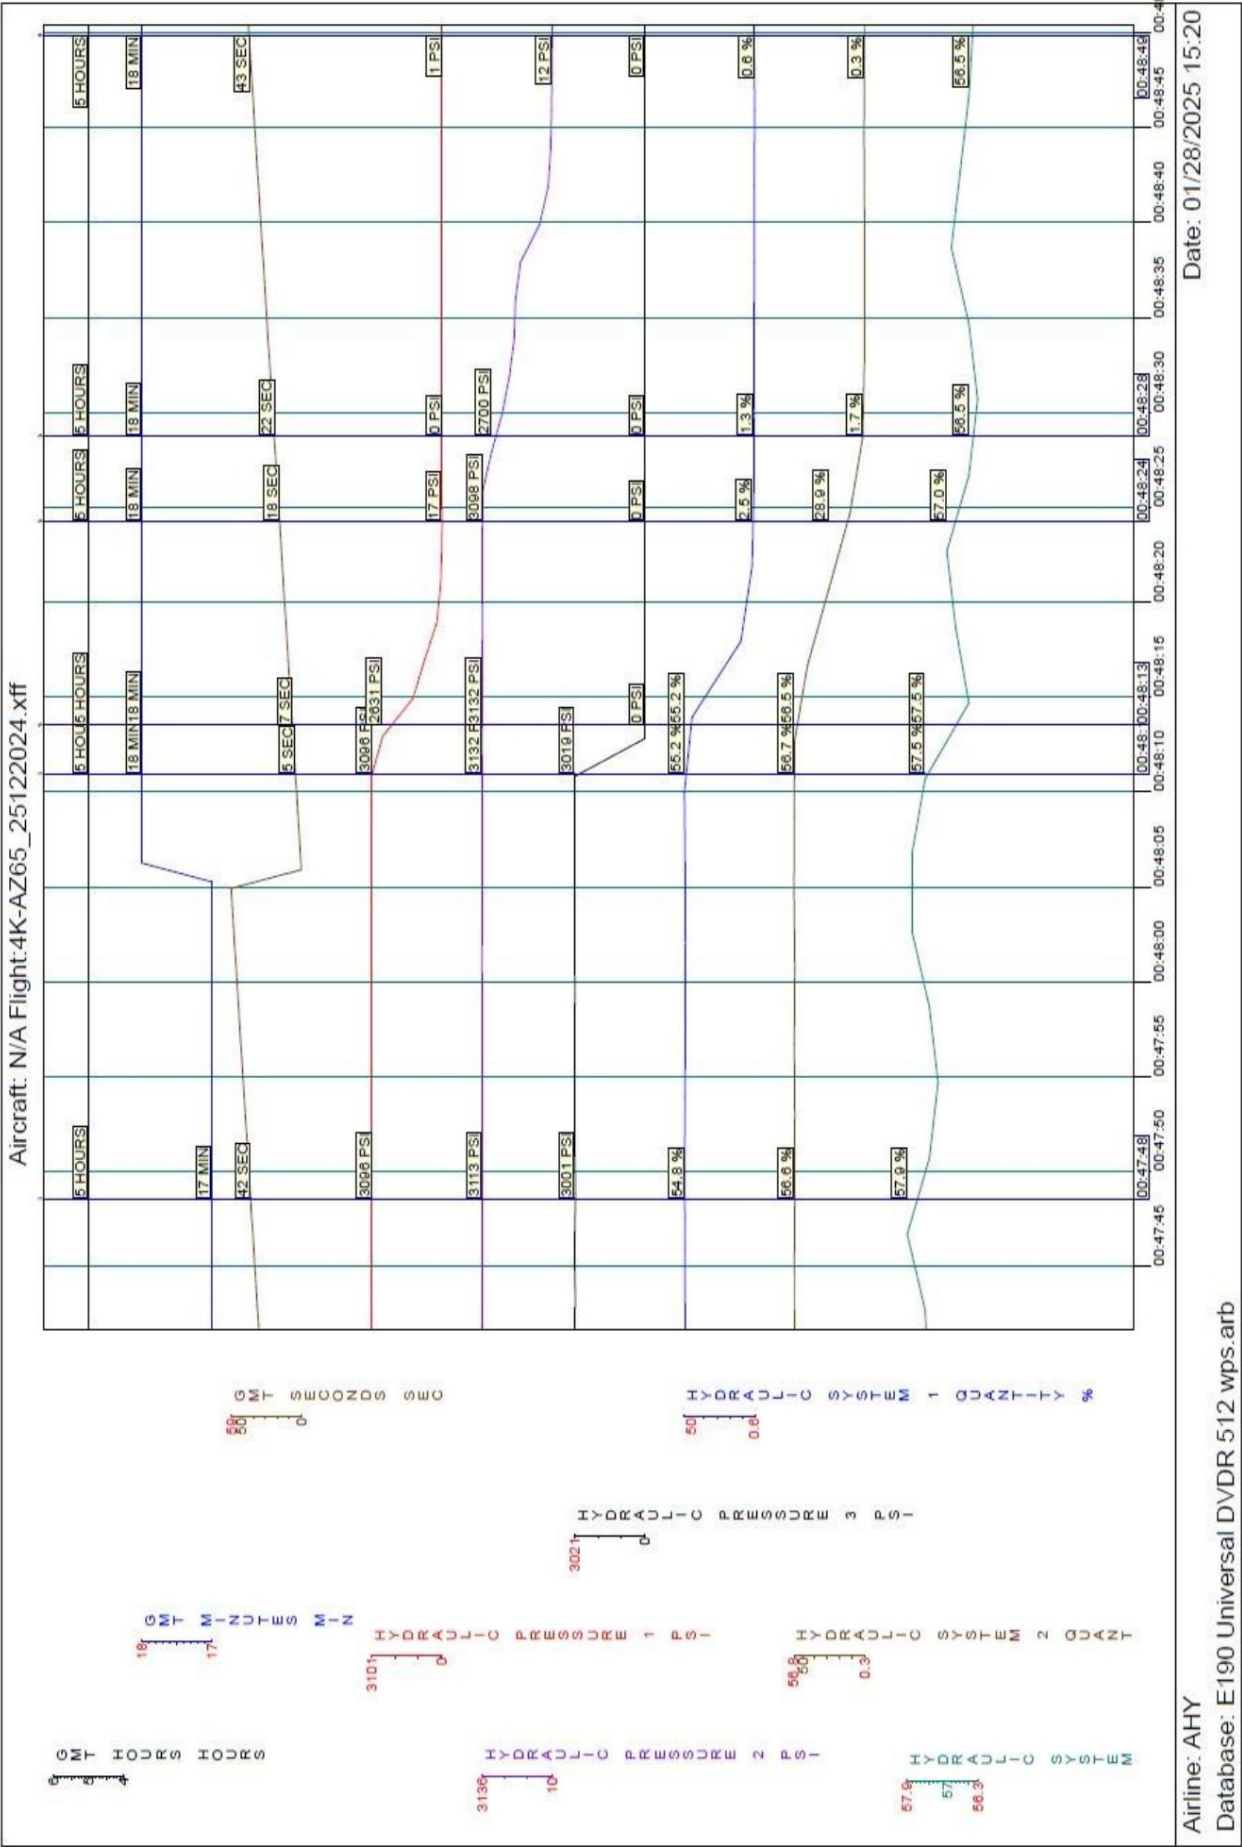
Fig. 17. Schedule of operation of hydraulic systems from mQAR

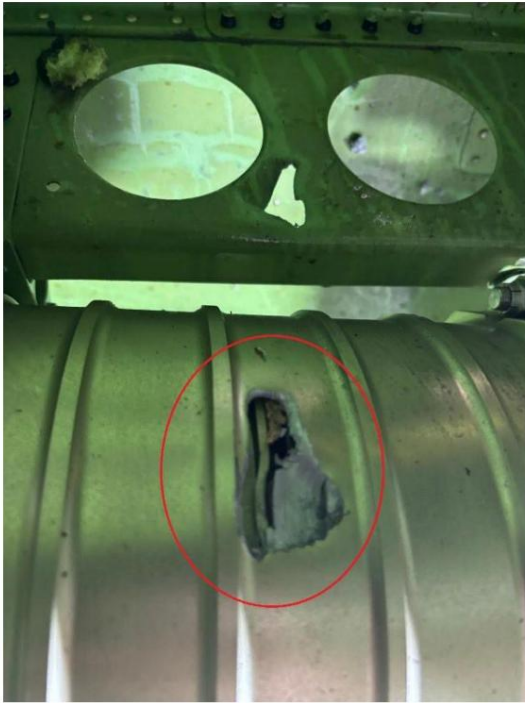
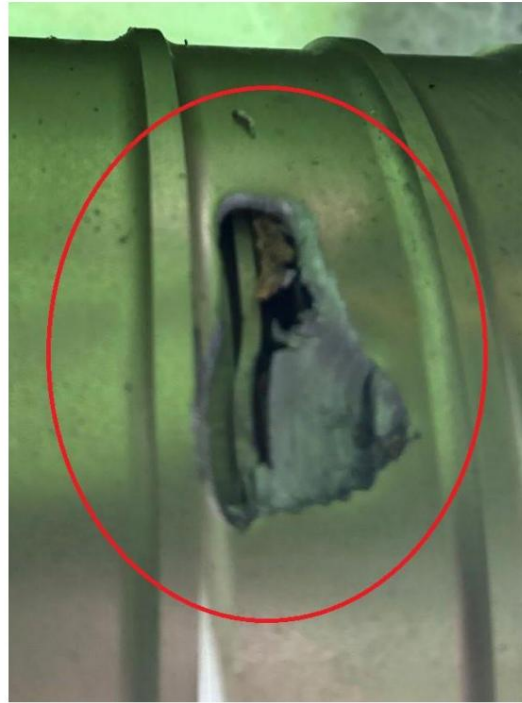
**Fig. 18. Hydraulic system 3 –  
damaged tank**

**Fig. 19. Hydraulic system 3 –  
detailed view of the damaged tank**

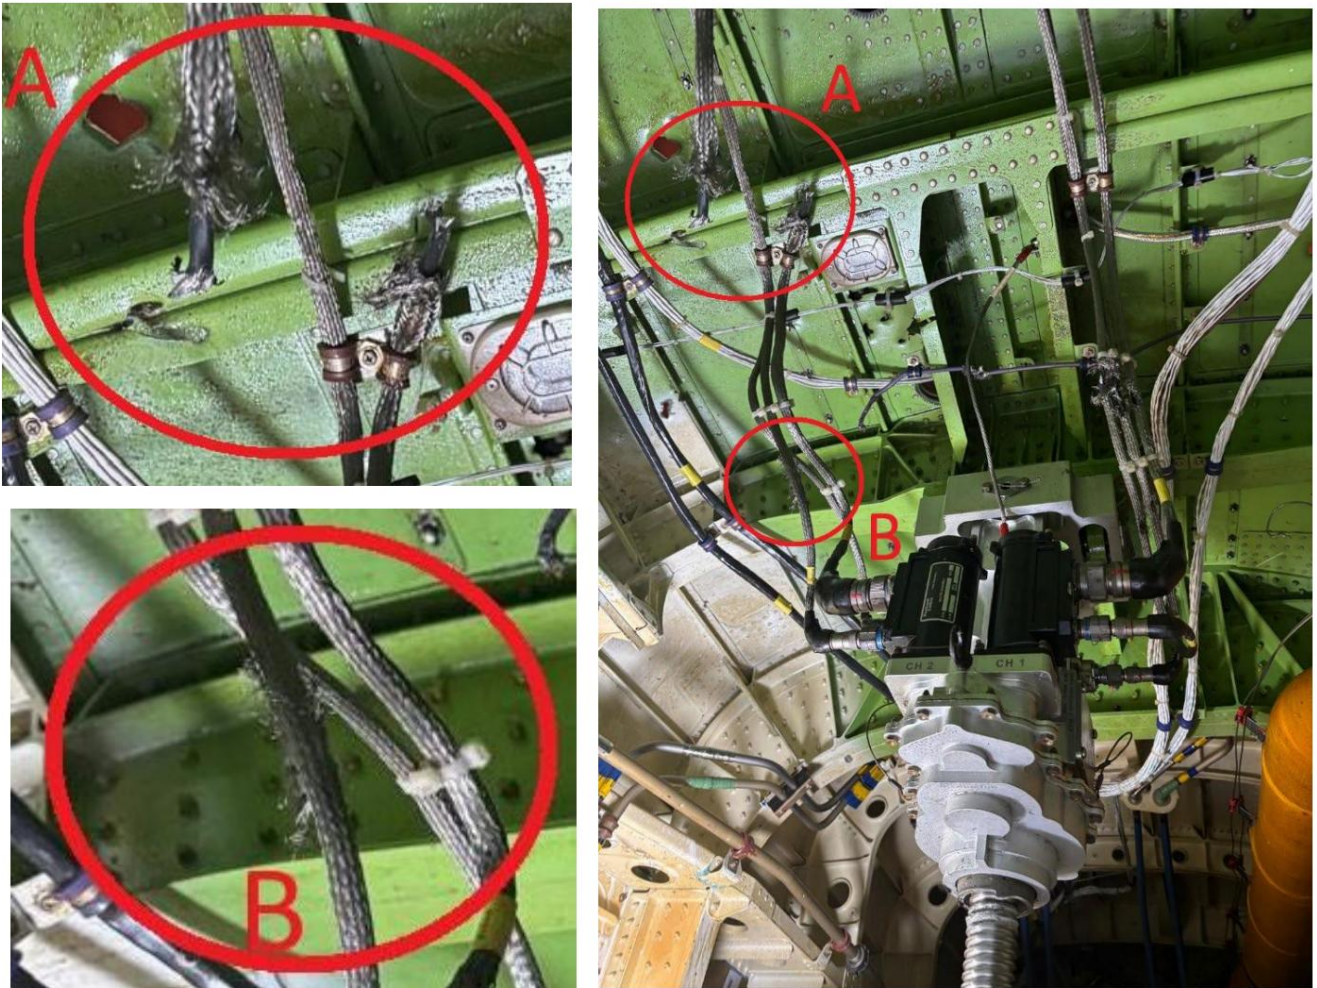
Below are photographs showing evidence of electrical damage.  
stabilizer drive control wiring (pitch trim) before impact with the ground  
surface, probably caused by external objects.

The consequence of these damages will be the inoperability of the first and second channels.  
trimming by pitch angle.

**Fig. 20. Stabilizer control mechanism****Through damage in the hydraulic system compartment No. 3 and the stabilizer control mechanism**

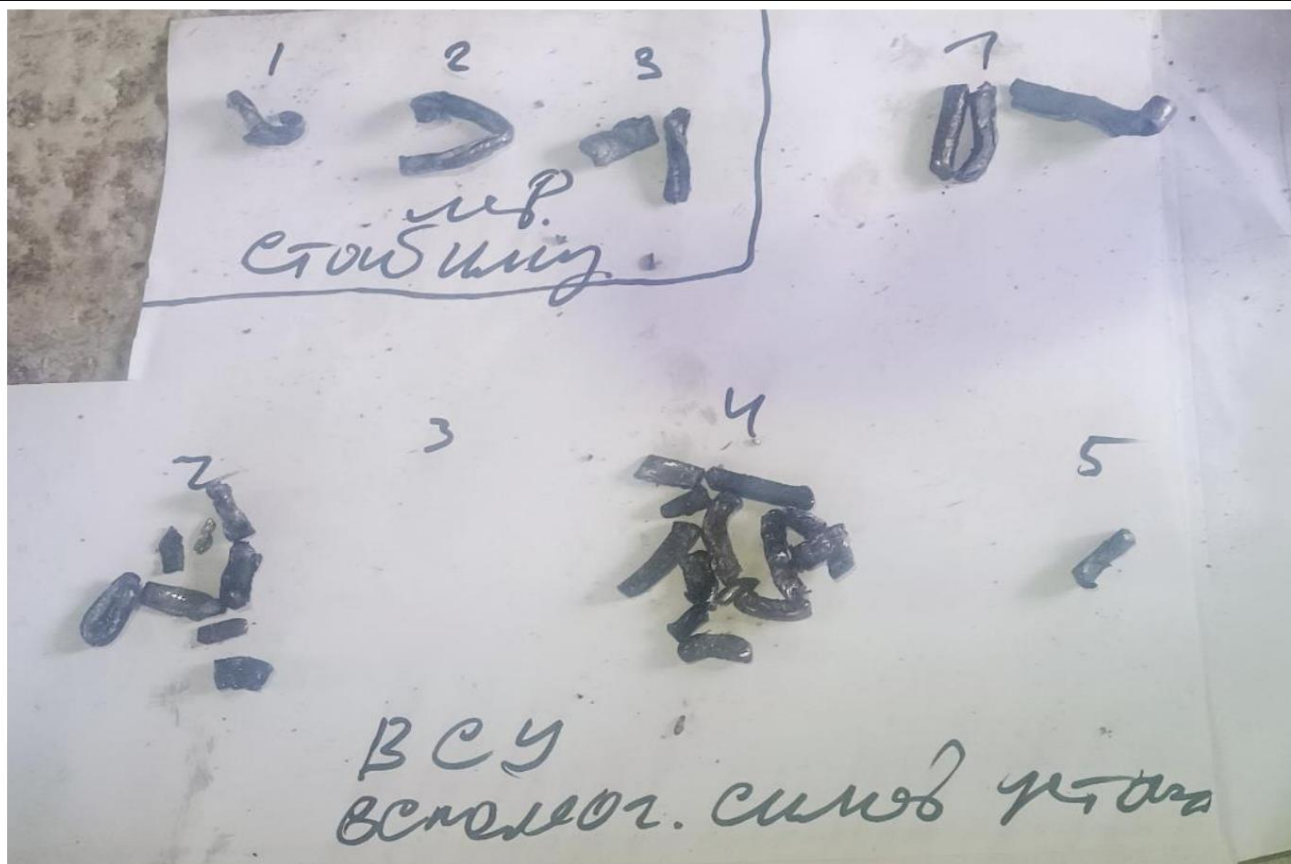
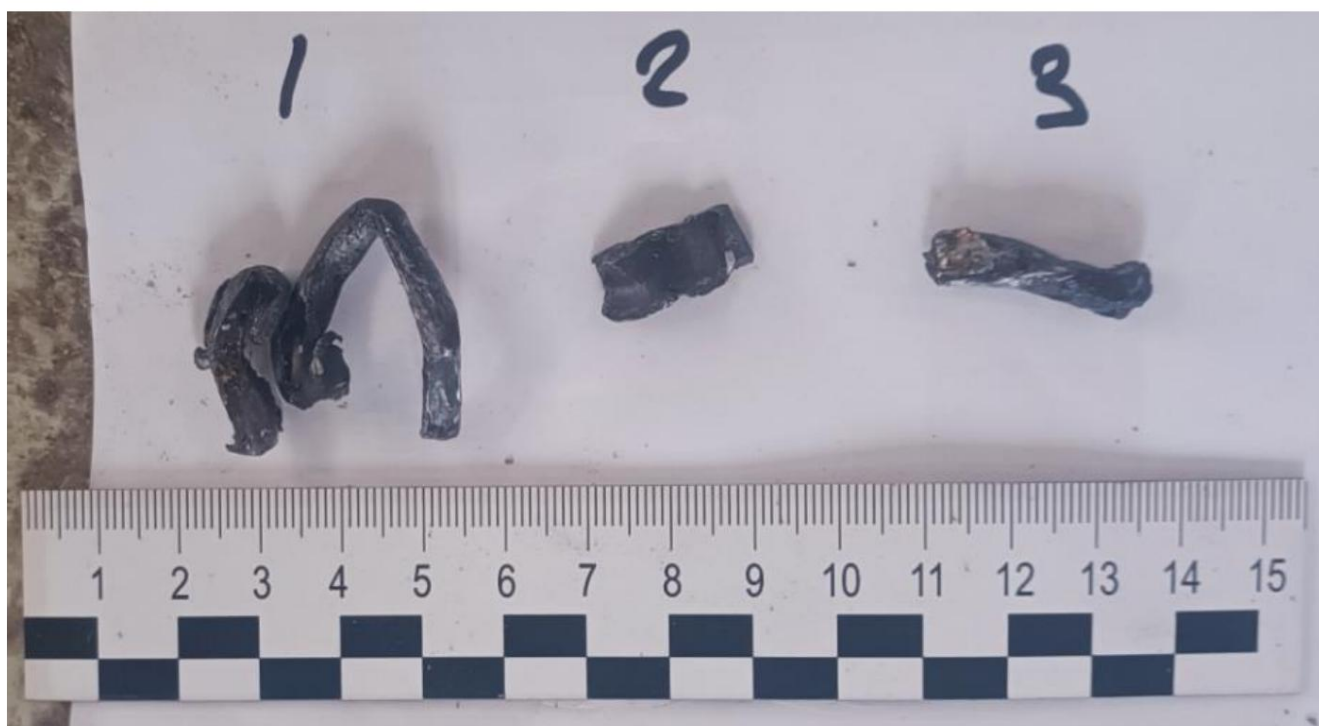
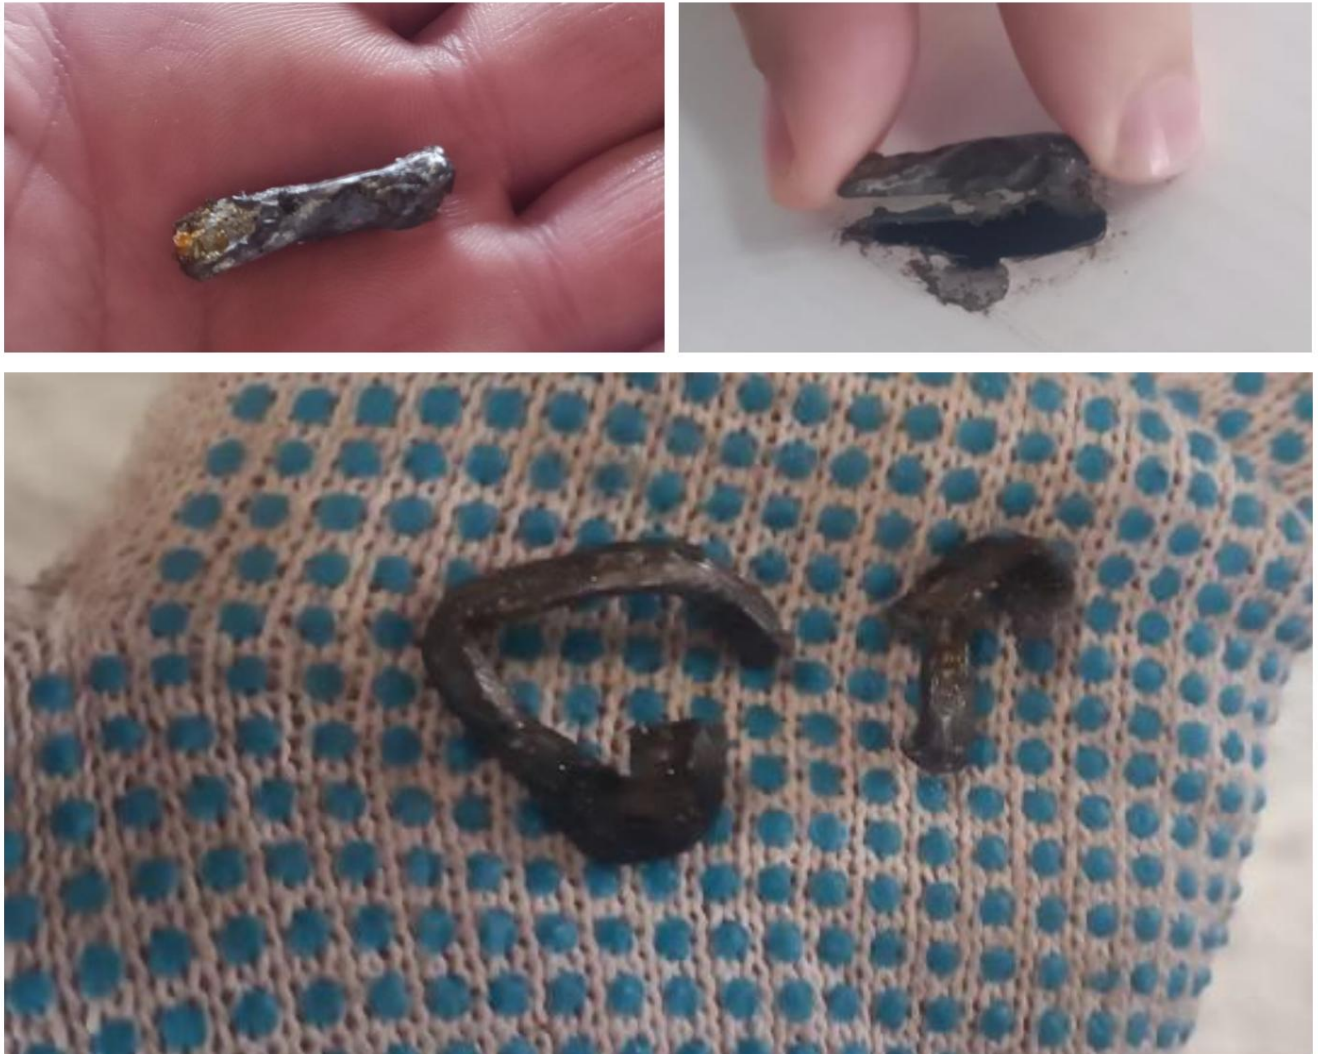
By the Investigation Commission in the presence of Authorized Representatives Federative Republic of Brazil, the Republic of Azerbaijan and law enforcement The authorities of the Republic of Kazakhstan carried out actions to remove foreign objects, which could be preserved in blind lesions, in order to direct them to additional forensic examination. As a result, a large number of pieces were extracted from the blind injuries. foreign objects.

Fig. 21. Part of the foreign metal objects removed from the left stabilizer and the APU compartment

Fig. 22. Part of the foreign metal objects removed from hydraulic system compartment No. 3 and the stabilizer control mechanism

**Fig. 23. Examples of extracted foreign metal objects**

To determine the nature and origin of through-and-through damage caused by foreign objects, appropriate research and examinations will be carried out.

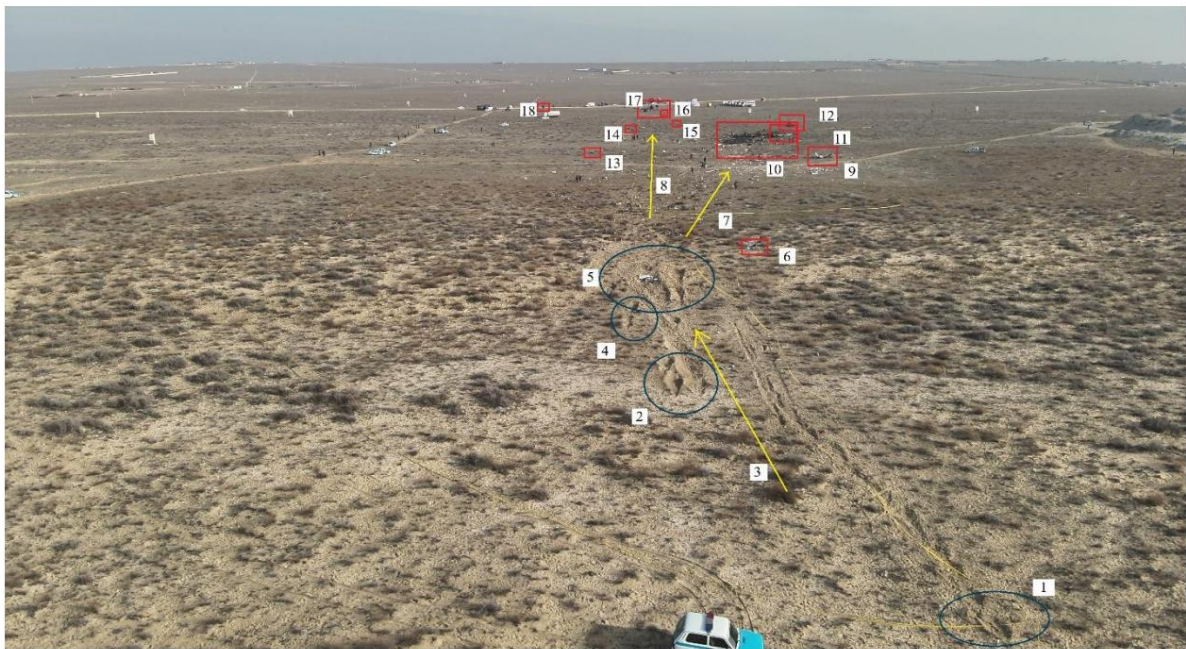
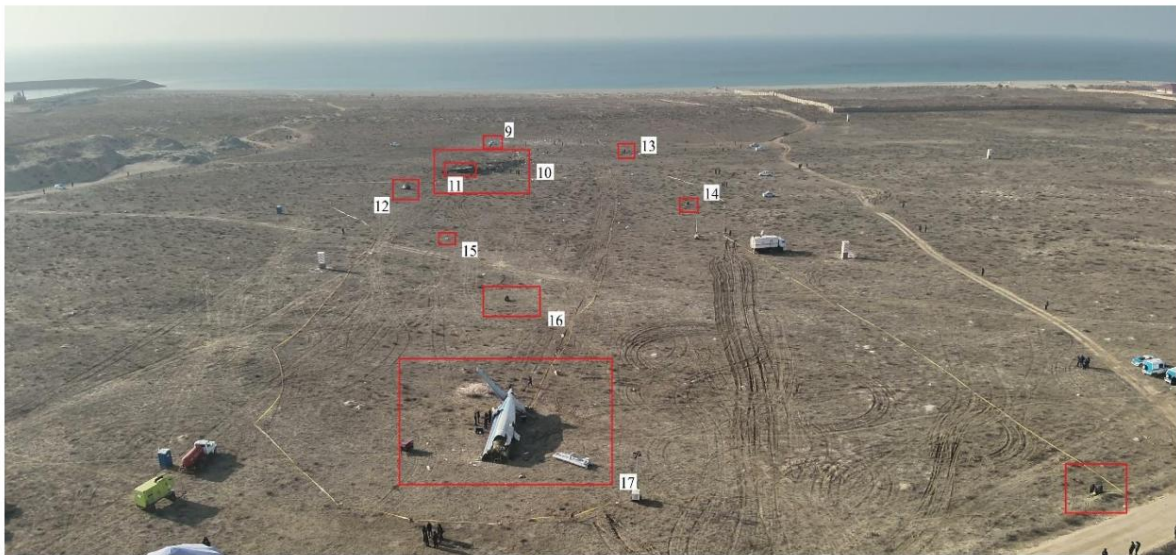
The chassis were destroyed and scattered around the site as a result of the collision. incident, the upper part of the left pillar remained in the niche of the left wing (15,16,18).

The right engine is destroyed into several large and small pieces (13,14). Left The engine is partially preserved (12).

Fig. 28. The location of the aviation accident and the scattering of elements

**Fig. 29. Location of AP and scatter of elements. View from the opposite direction**
