**MINISTRY OF TRANSPORT OF THE REPUBLIC OF KAZAKHSTAN**  
**AVIATION ACCIDENT INVESTIGATION COMMISSION**

**PRELIMINARY REPORT**  
**BASED ON THE RESULTS OF THE INVESTIGATION OF THE AVIATION ACCIDENT**

| Aircraft type: | Embraer ERJ 190-100 IGW |
| State and registration<br>identification marks: | 4K-AZ 65 |

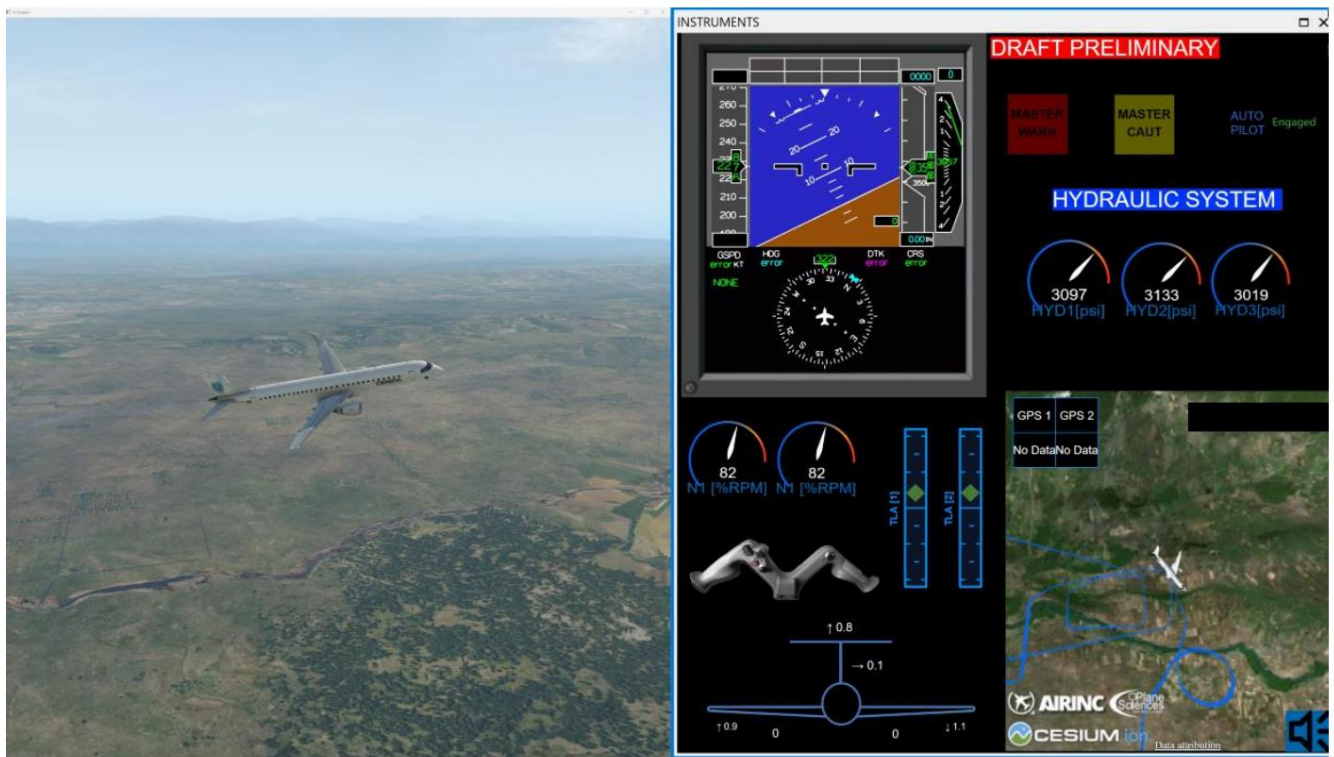
Fig. 1. Reconstruction of the flight before the occurrence of the exceptional situation

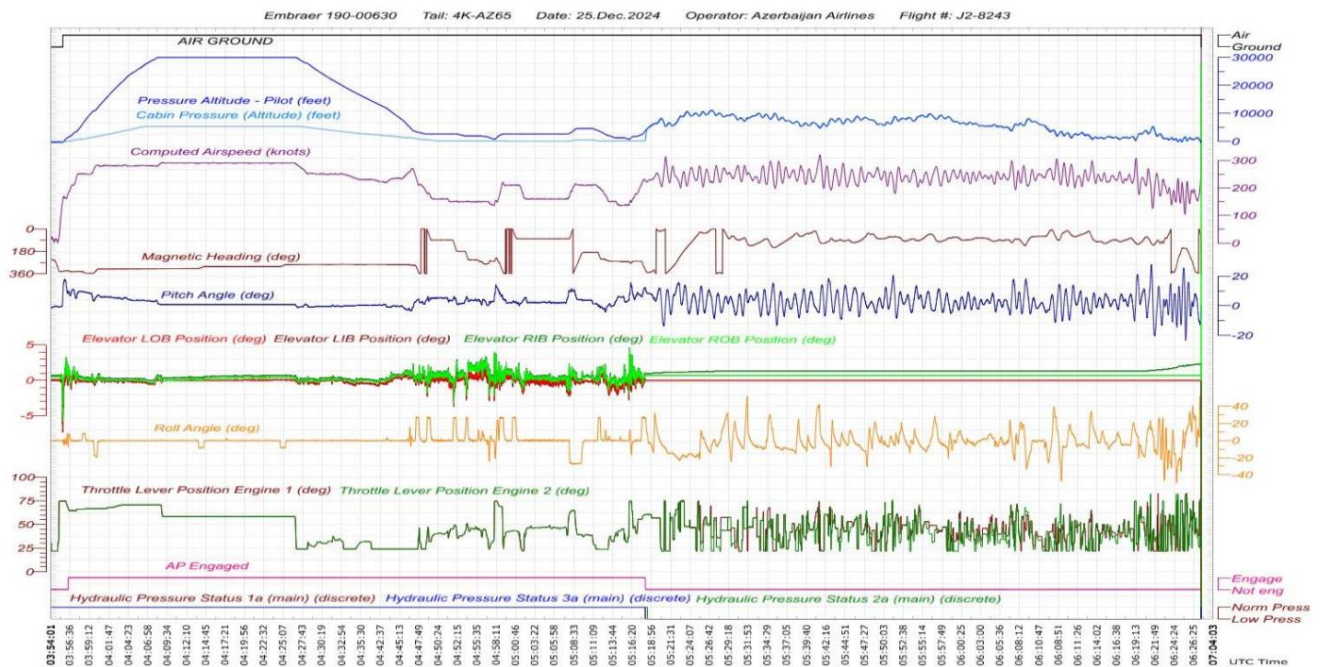
Fig. 2. Flight parameters 12/25/2024

**Note:** From 04:37:18 to 06:07:57 the recorded FDR time is ahead of UTC time for 4 minutes 32 seconds.

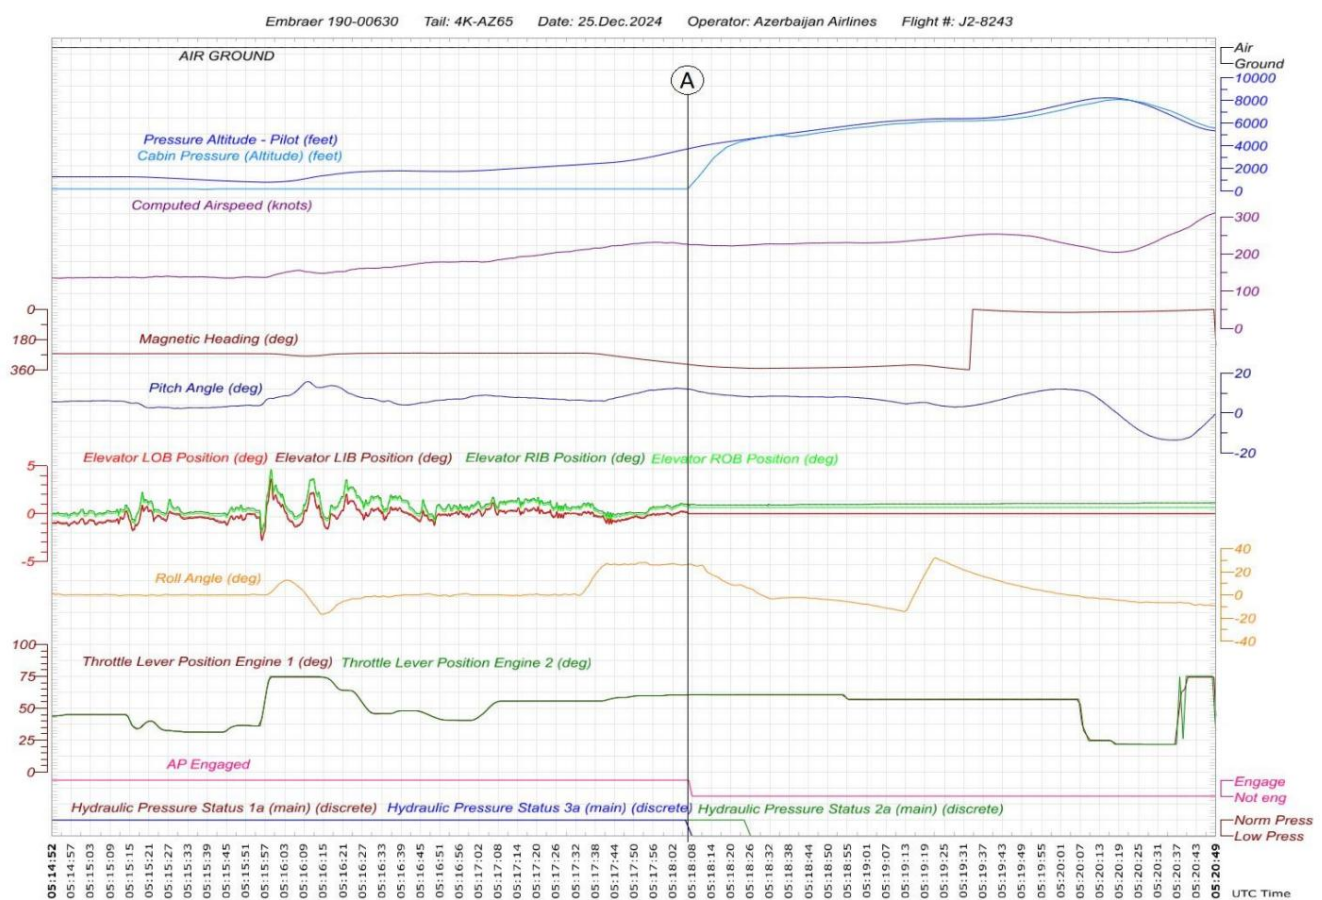
05:13:47 the alarm "HYD 2 LOW PRESS" was triggered. Pressure in the 1st hydraulic system dropped to 0 PSI. The fluid level in the 1st hydraulic system dropped to 0%.

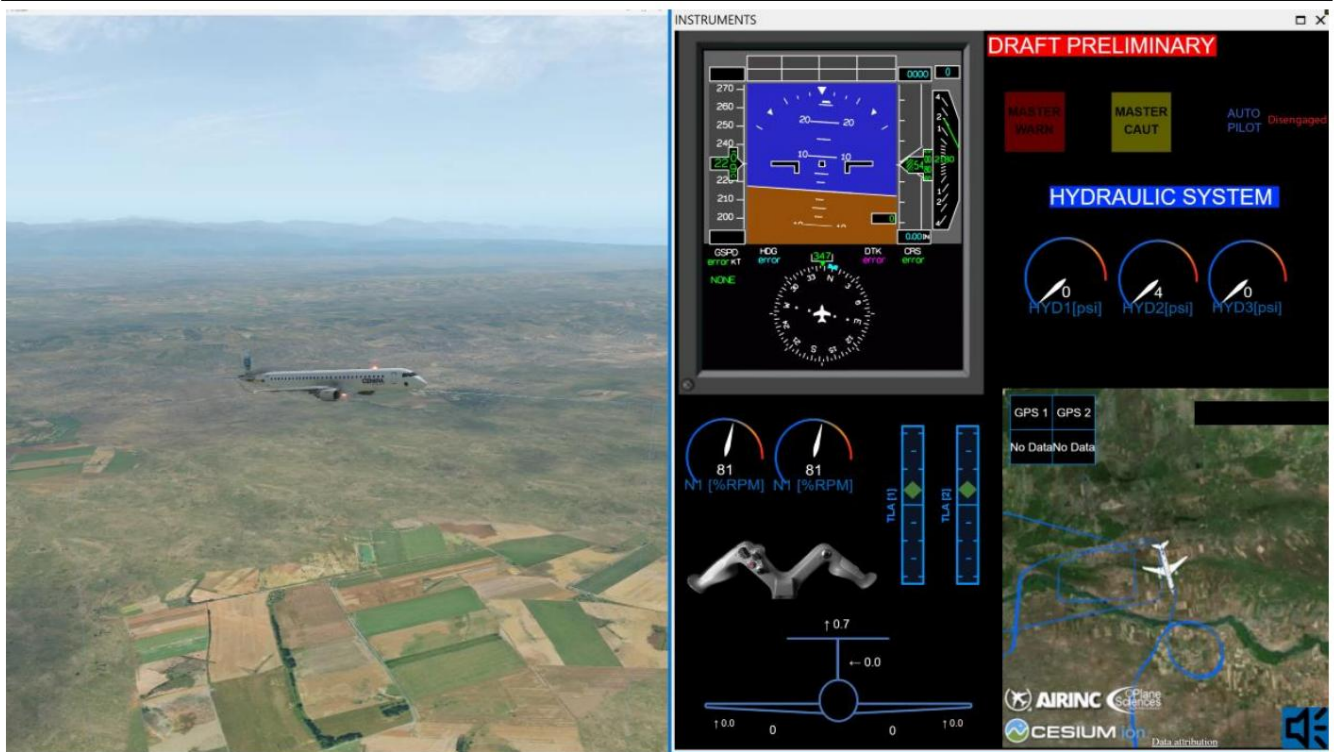
05:13:54 (FDR) The pressure in the 2nd hydraulic system dropped to 4 PSI (Fig. 4).

Fig. 4. Flight reconstruction after the occurrence of a special situation.

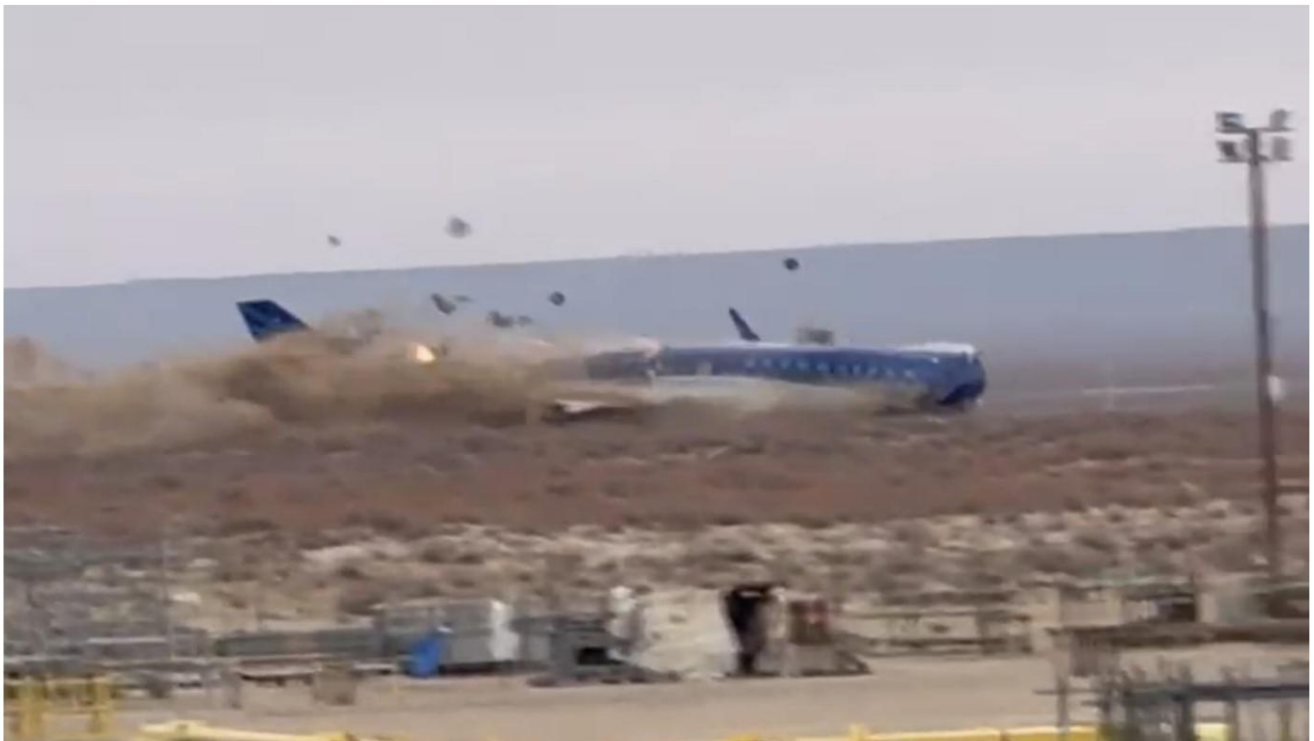
The site of the accident involving the E-190 is located approximately 5 km from Aktau International Airport in a northwesterly direction.

**Fig. 27. The moment of collision of the aircraft with the earth's surface**
